Manhole Inspection Summary

Manhole # S45GG_033MH

Inspection ☐ Is Incomplete Rating: **3) Fair**

Insp Date: **3/13/08 9:05 AM**

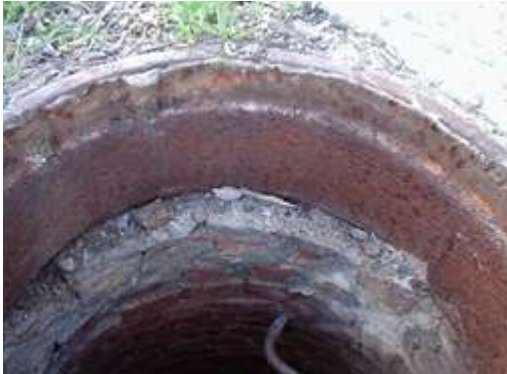
Defect 2

☒ **Leaks**

frame leaks

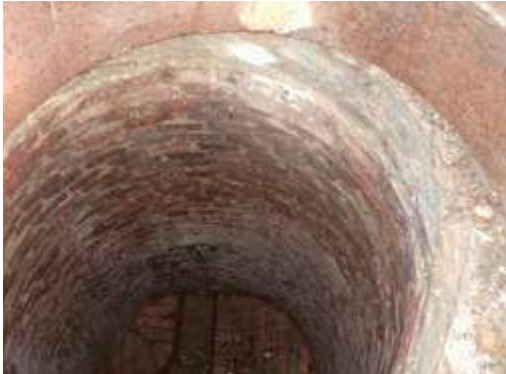
Defect 1

Offset: **3** (in.)

offset

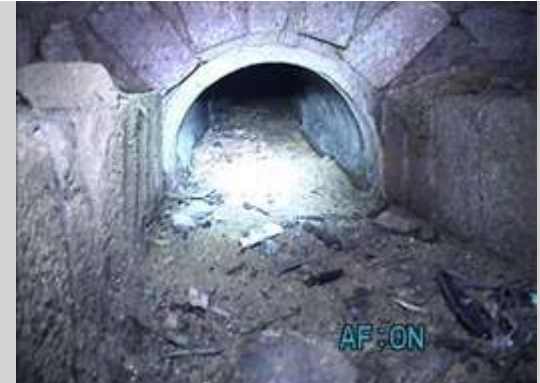
12 O'Clock Outflow

Pipe Height: **8.4** (in.) Rod and Bar (Angled)
Pipe Material: **Clay** ☐ Pipe Lined
Invert Depth: **10.30** (ft.) Flow Characteristics: **None**
Deposits: ☐ None ☒ **Mud** ☐ Sludge ☒ **Debris** ☐ Grease
Silt Depth: **2** (in.) Deposits Extent: **Light**
Infiltration: **None** Pipe Seal Cond: **Sound**

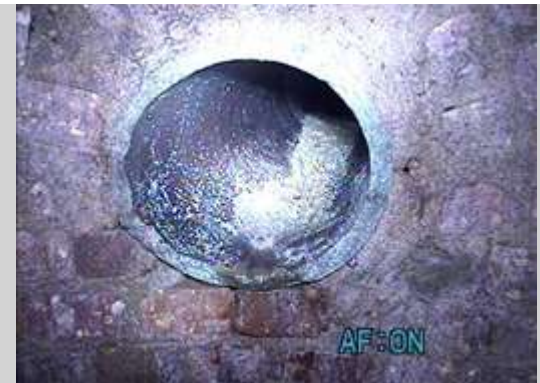
3 O'Clock Inflow

Pipe Height: **8.4** (in.) Rod and Bar (Angled)
Pipe Material: **Clay** ☐ Pipe Lined
Invert Depth: **6.60** (ft.) Flow Characteristics: **None**
Deposits: ☐ None ☒ **Mud** ☐ Sludge ☒ **Debris** ☐ Grease
Silt Depth: **1** (in.) Deposits Extent: **Light**
Infiltration: **None** Pipe Seal Cond: **Sound**

Drop: **Inside** Rod and Bar
Angled: **Yes** Reading: **9.10** (ft.)
Inv Depth: **10.10** (ft.)
